## Home In Brooksville Florida Contractor should have used Tuf-Link

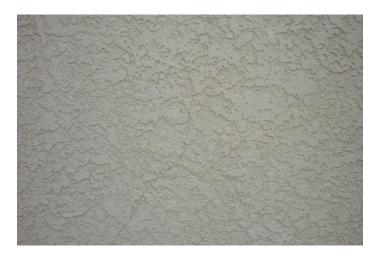
**Hydration Cracks**
