**Subdivision – Land O’ Lakes Florida**  
**Contractor should have used Tuf-Link!**

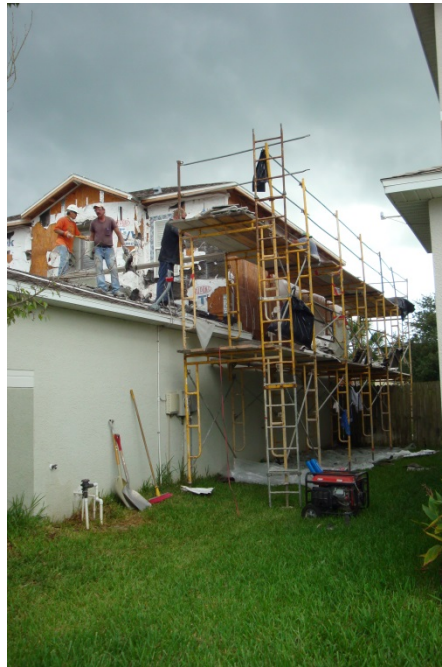
Expensive Repair

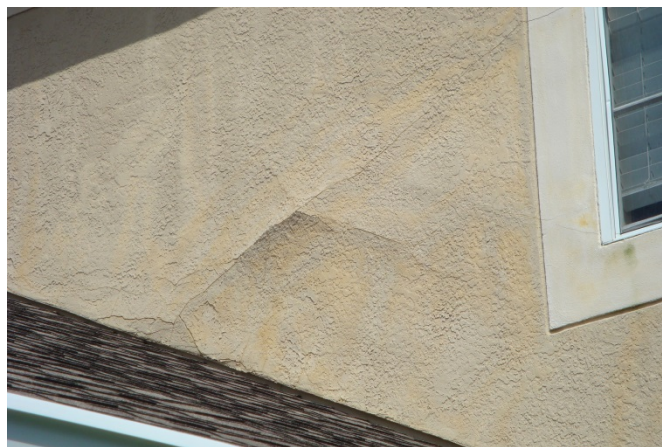
Delamination from water penetration

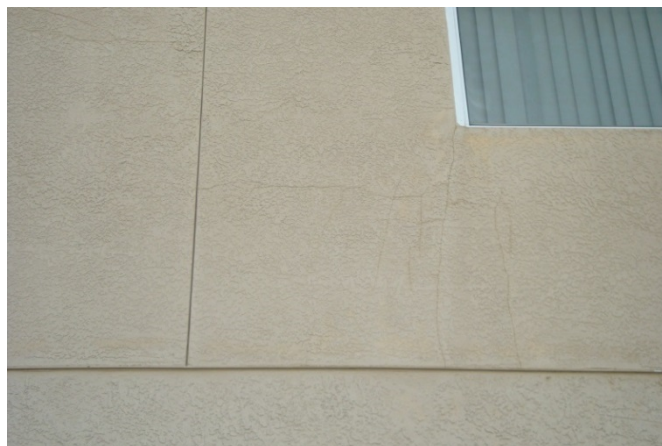
Hydration Cracking

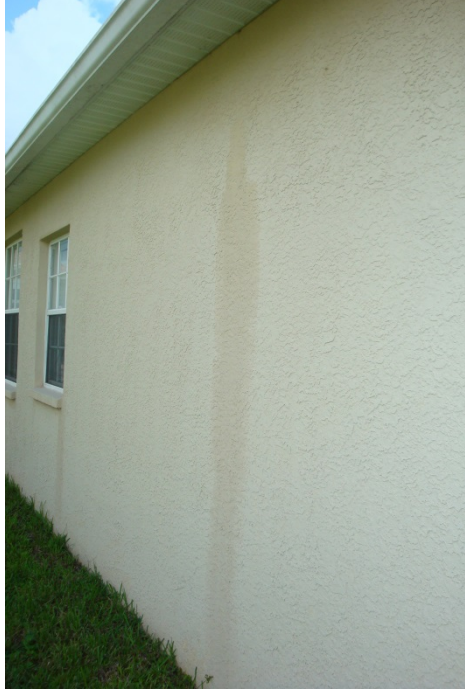
Water Penetration
