TAMPA SCHOOLS

THE PROBLEM

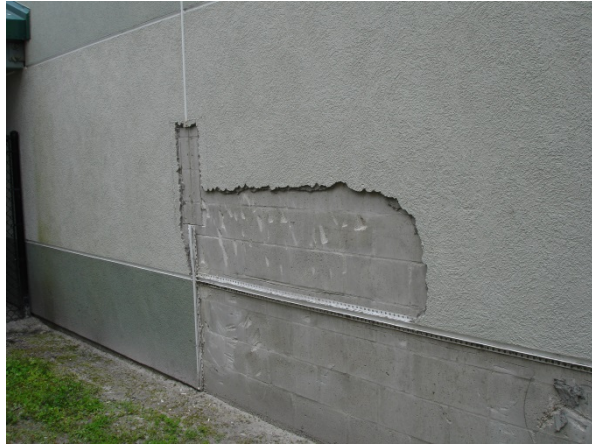
Deer Park School Stucco Repair

The problem was thoroughly evaluated by the District’s Technical Staff and outside consultants. It was determined that a large portion of the stucco must be replace, and properly bonded with a non-rewettable water resistant bonding material. Tuf-Link was chosen for the job which currently under way – summer 2013. The cost was substantial!

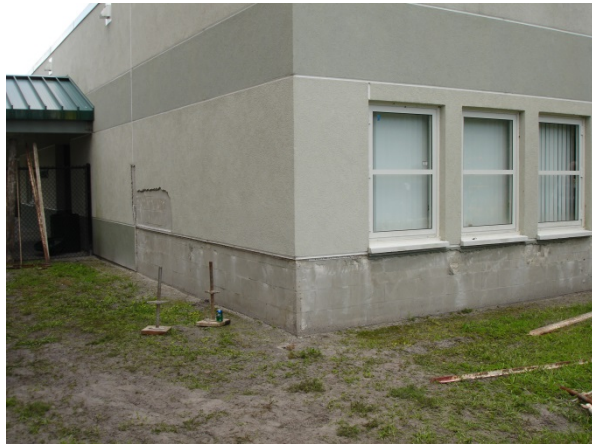
Deer Park School - More Stucco Repair

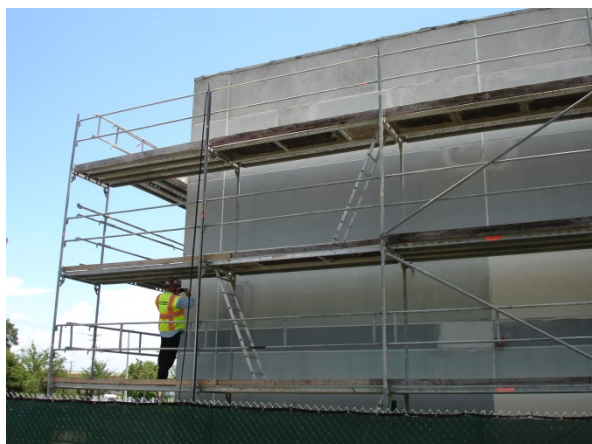
Oak Park School - More Stucco Repairs
